Appendix L

Ecology Chapter Appendices

Widening of Tolo Highway / Fanling Highway between Island House Interchange and Fanling Stage 1

Ecological Survey

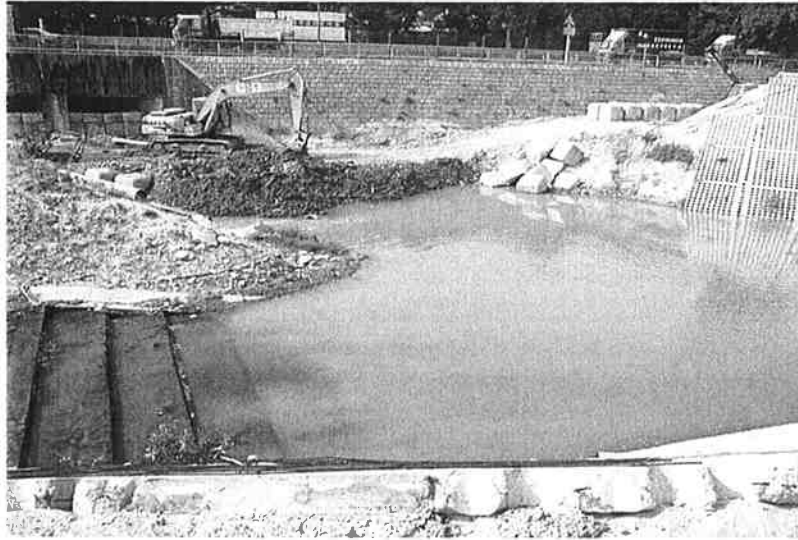
Upstream Monitoring Location (Location 1)

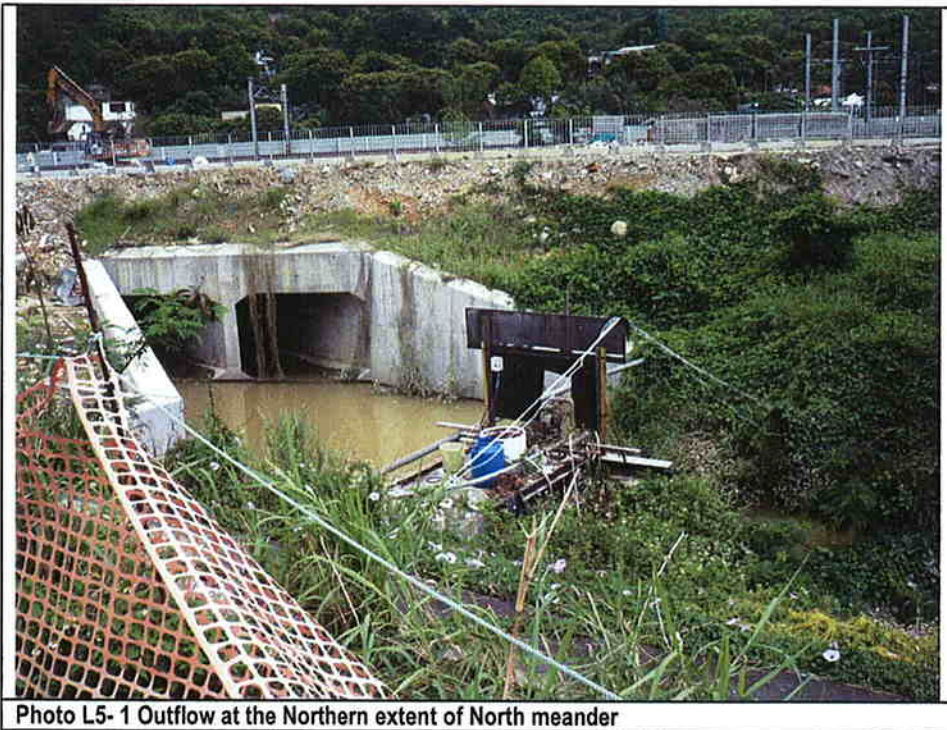
Photo L5- 1 Outflow at the Northern extent of North meander

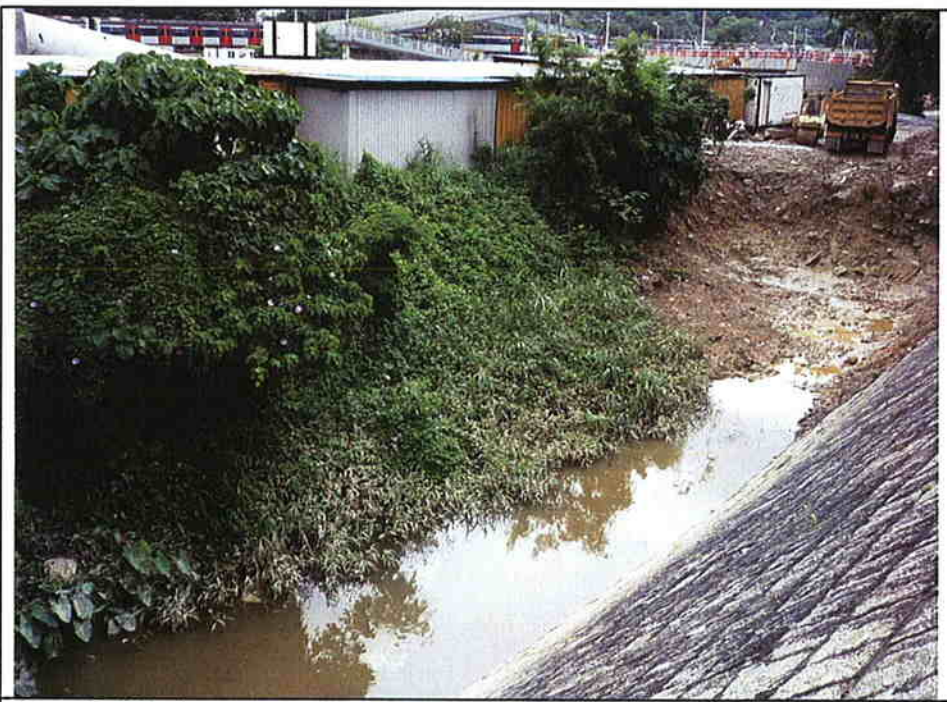
Photo L5- 2 Outflow at the Northern extent of North meander

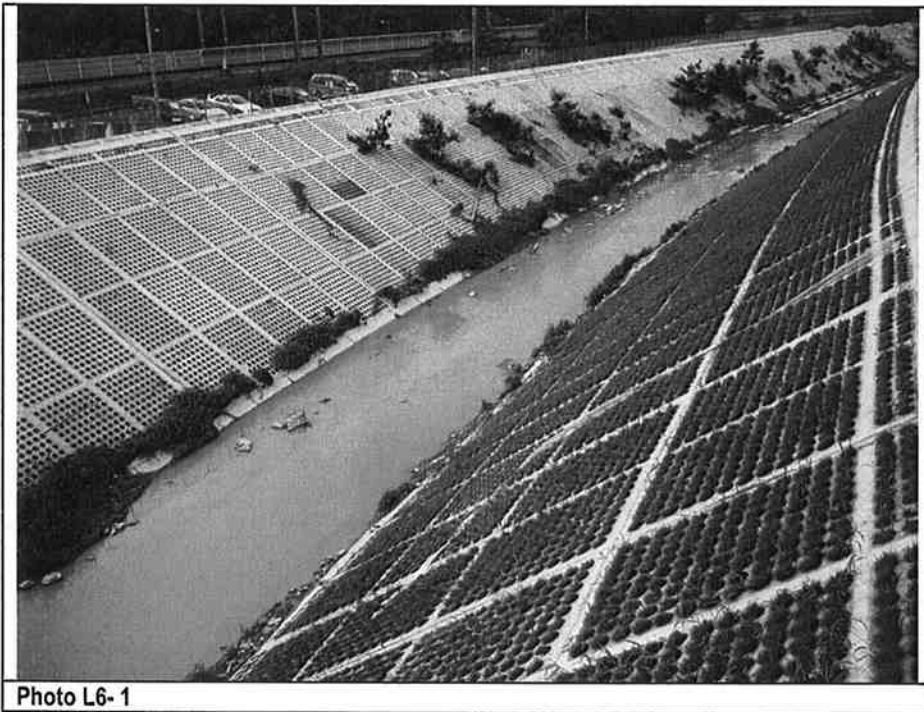
Photo L6- 1

Appendix L-6 Existing condition of the Drainage Channel

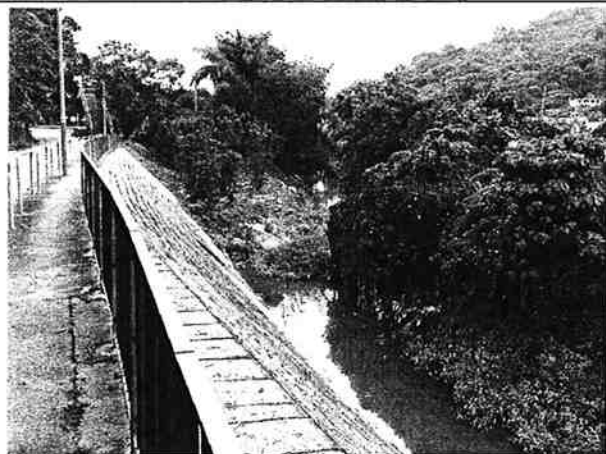
Photo 1: General view of the meander

The field survey was defined as the areas of the affected meander which is approx. 90 meter in length. The meander belongs to old Ma Wat River (Photo 1). The surveys were designed to collect data to supplement ecological information to previously approved EIA of Widening of Tolo/Fanling Highway. Special attention was paid to rare/protected species of flora and fauna which would be directly impacted by the proposed road works.

The affected meander was isolated and disconnected from the original old Ma Wat River due to river improvement works which re-channellized the river. High water turbidity and bad smell was observed at the meander during field survey.

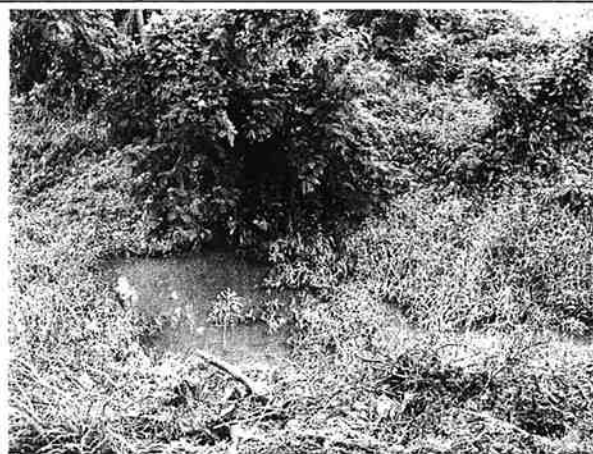
Photo 2: The view of Transect 1.

Riparian vegetation including aquatic and emergent plants was surveyed by line and belt transects along the affected river meander and its riparian habitat (Photo 2-4). Species, relative abundance, average heights was recorded. Major trees outside sampling transect, but within survey area were also recorded as part of the flora baseline information.

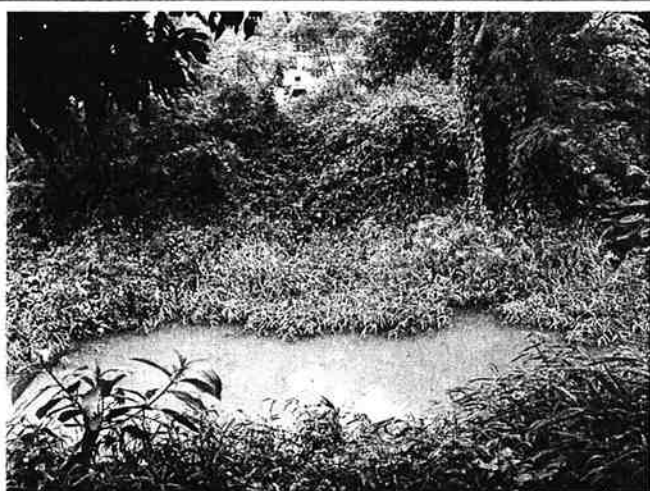
Photo 3: The view of Transect 2.

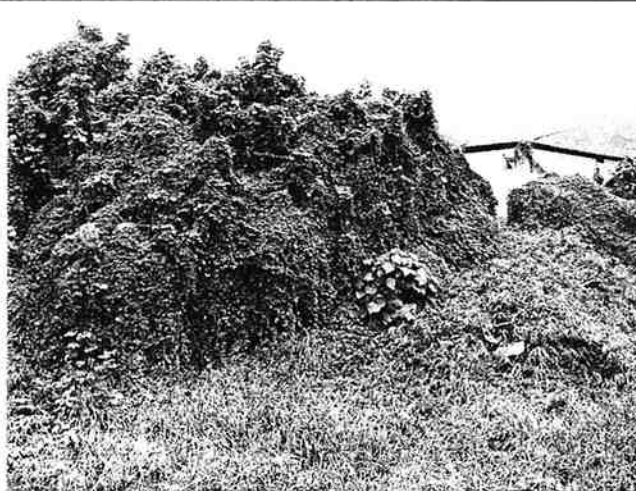
Photo 4: The view of Transect 3.

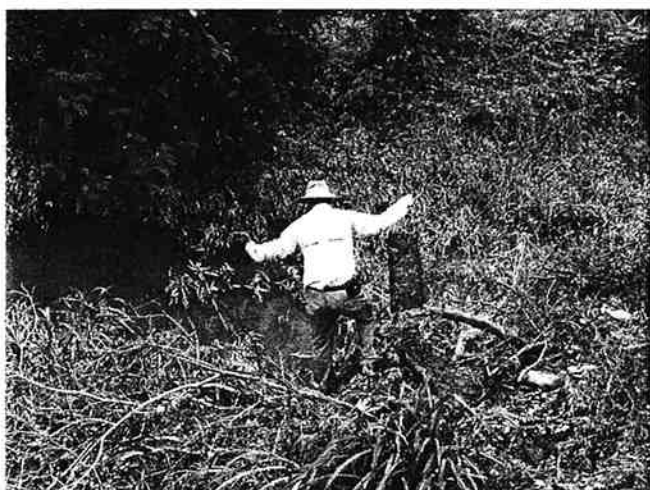
Photo 5: Live trapping

Fish community, amphibian and reptile at the specified river meander was surveyed by live trapping (Photo 5), hand nets (Photo 6) and direct observation methods.

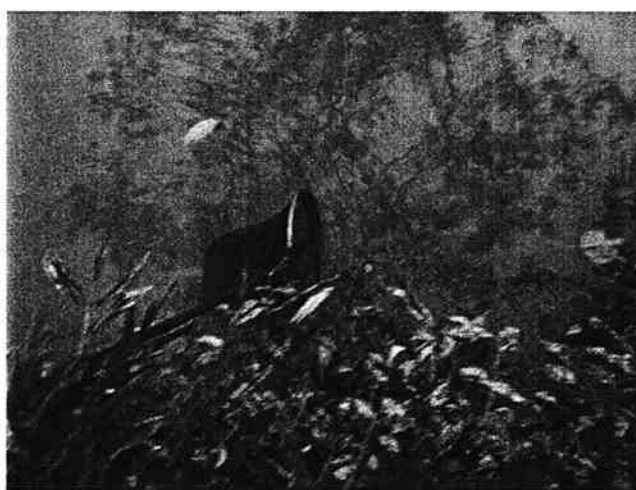
Photo 6: Hand netting

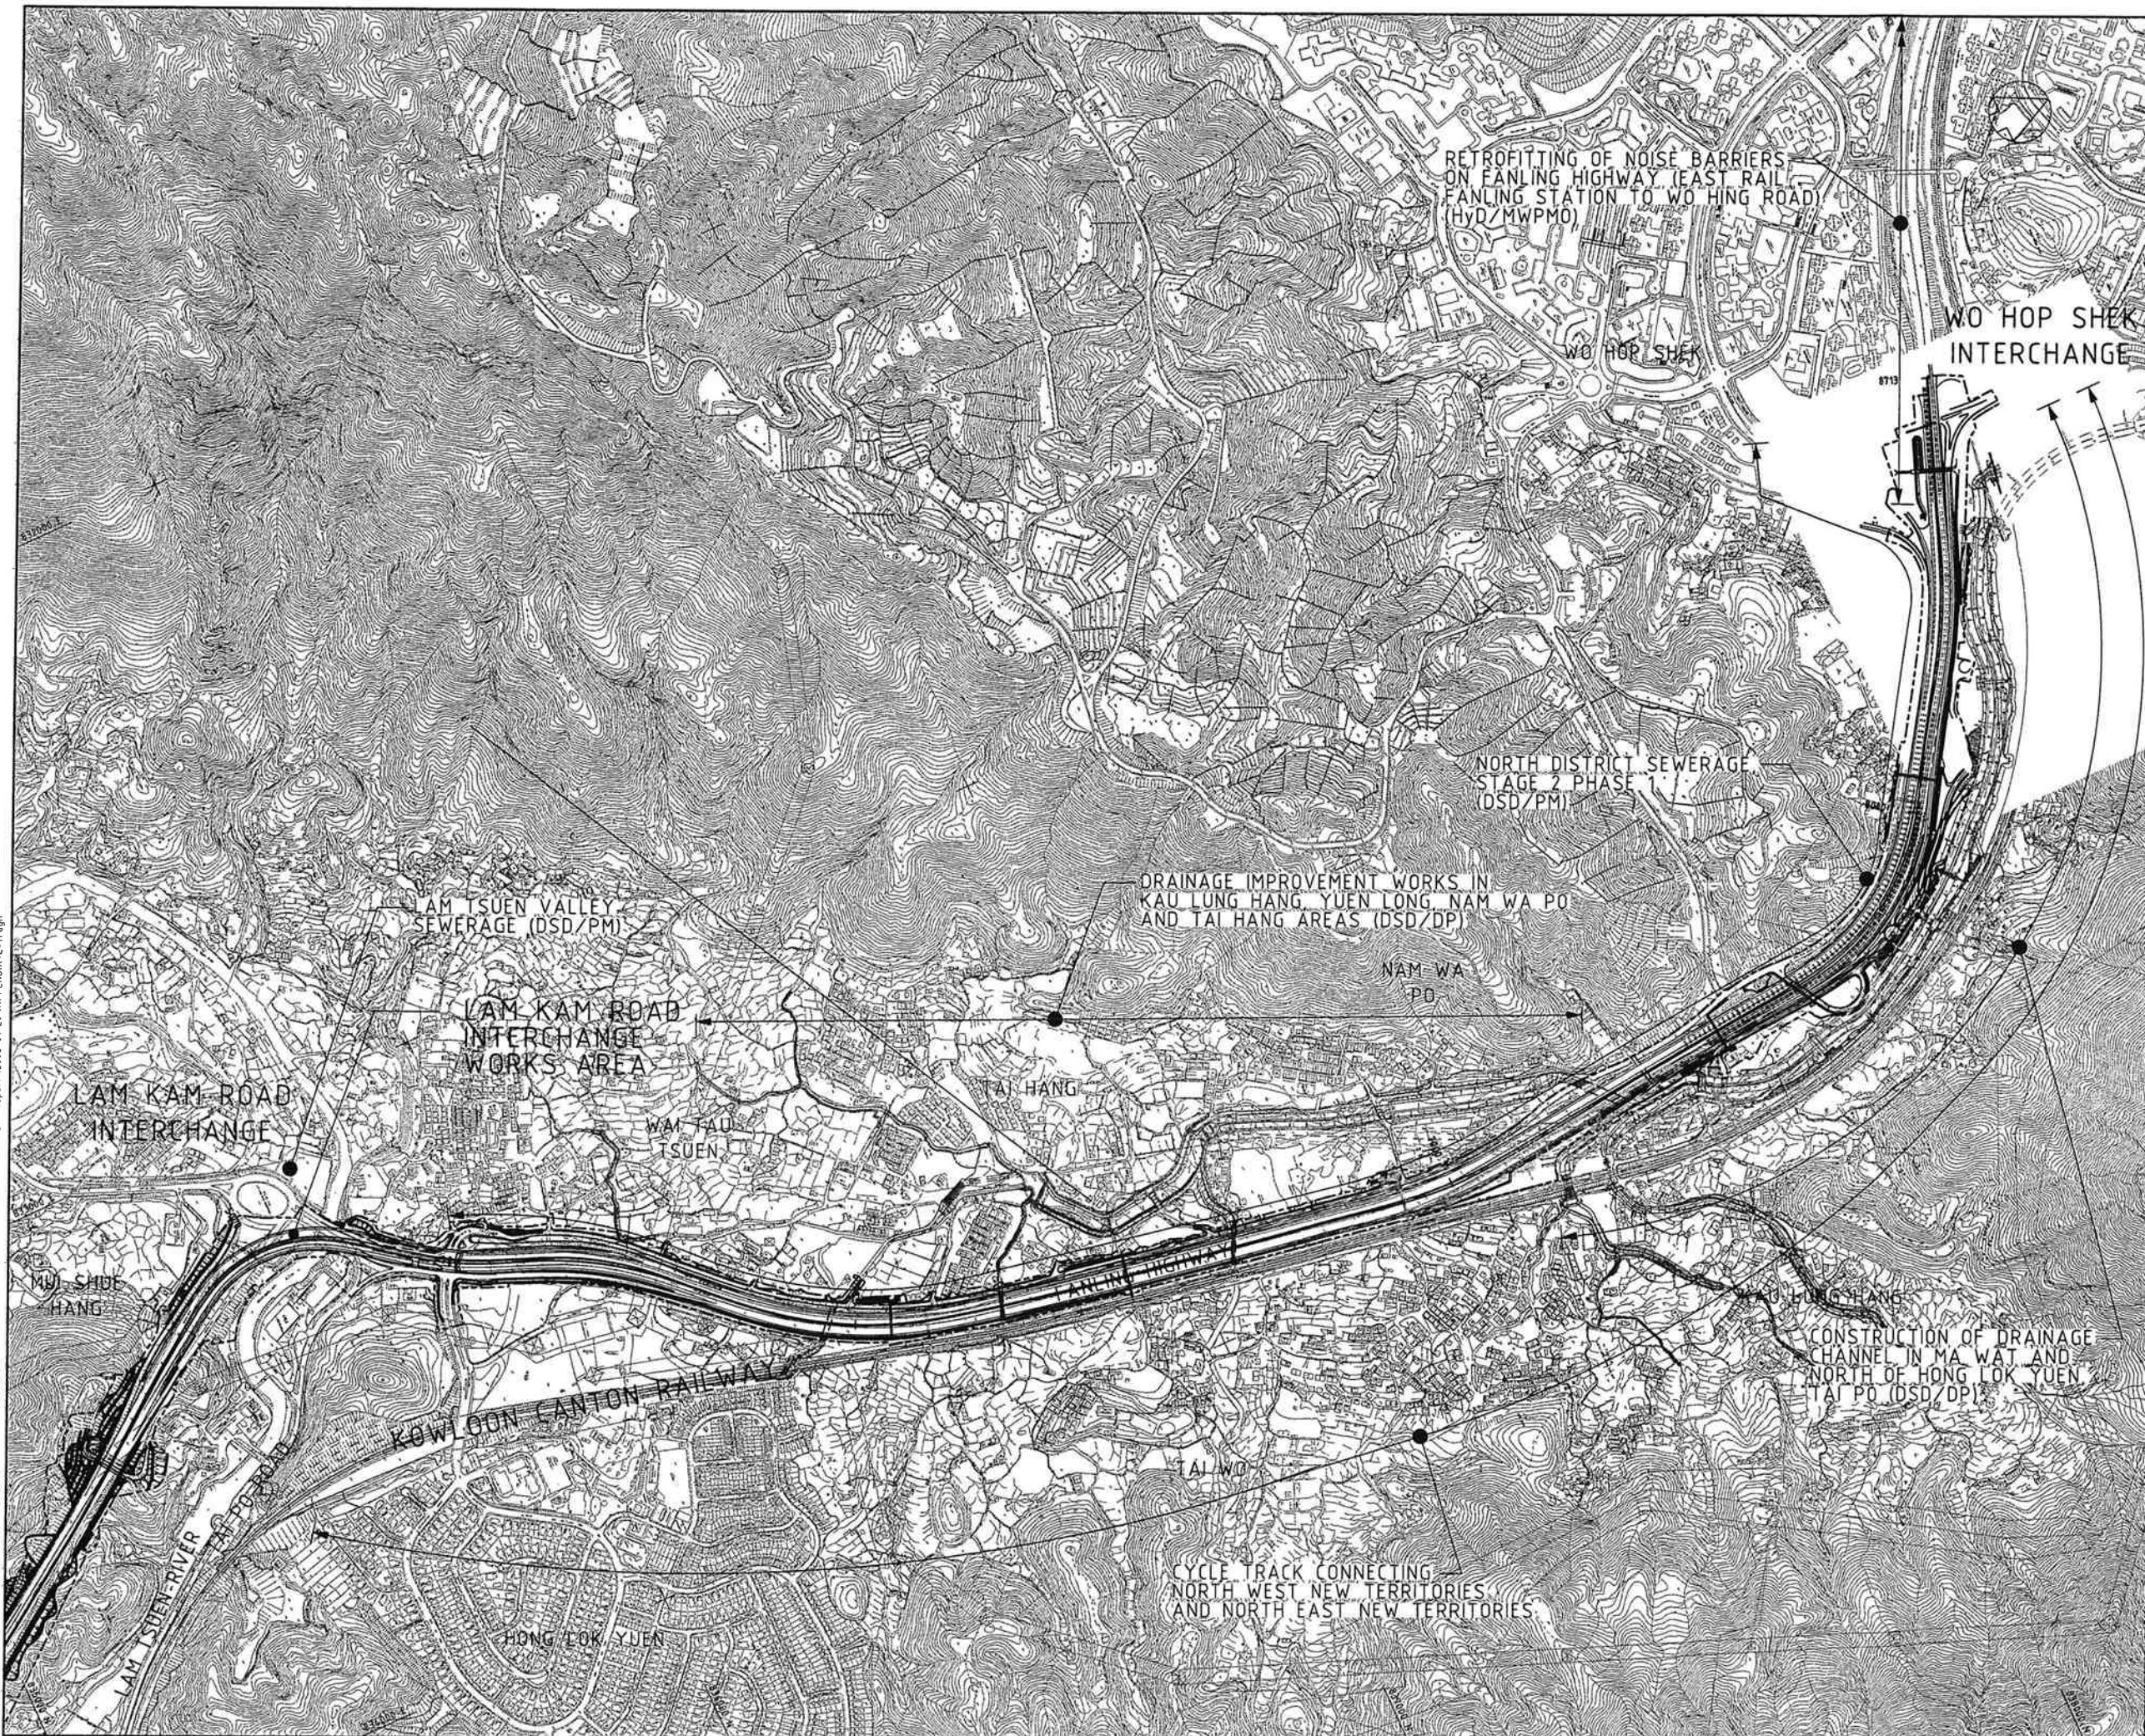
CONSULTANT 工程顧問				
Hyder   ARUP   BLACK & VEATCH Consulting				
DRAWING TITLE 圖名				
LOCATIONS OF INTERFACE PROJECTS				
STATUS 圖況				
DRAWING NO. 圖號				
APPENDIX I - 11				
REV. 修訂

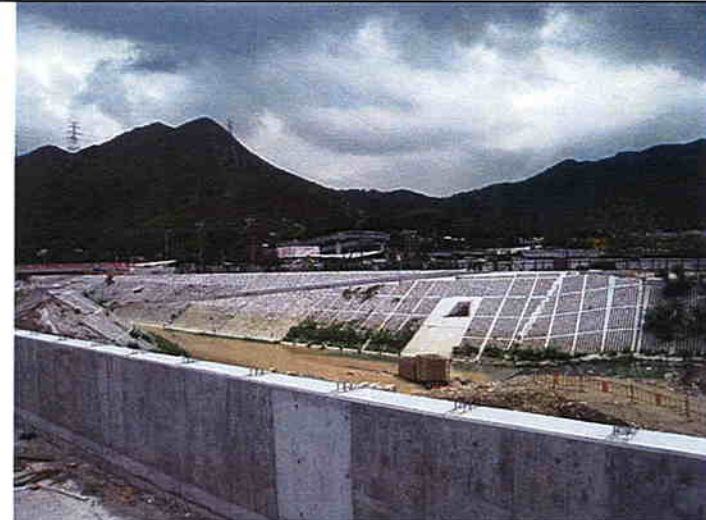
Photo taken on 13th November 2007, viewed towards Ma Wat River near Kiu Tau illustrating **Artificial Drainage Channel** (downstream of Kau Lung Hang EIS).
